Case study on Septx Compound Use in the field of wastewater treatment process

Site: Hilton Marsa Alam

Duration: Thursday, 17th, 09, 2015 to Sunday, 27th 09, 2015

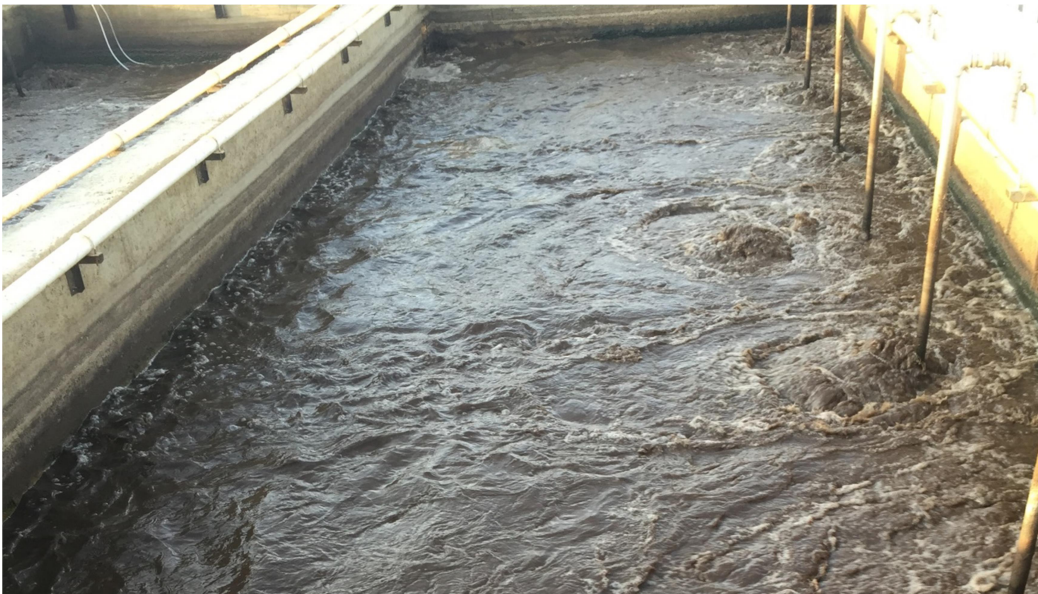
The walls of the ventilation basin in pre-treatment (showing dense sediments on the walls of the basin):

- Before treatment, big sediments were observed on the walls of all the basins of the station either reception or sedimentation or ventilation.
- Beginning of the second day of the experiment, the workers noticed that the walls of sediment basins began to precipitate decompose and thaw in the sink until it started gradually to disappear and the color of the walls seemed to turn back to white.

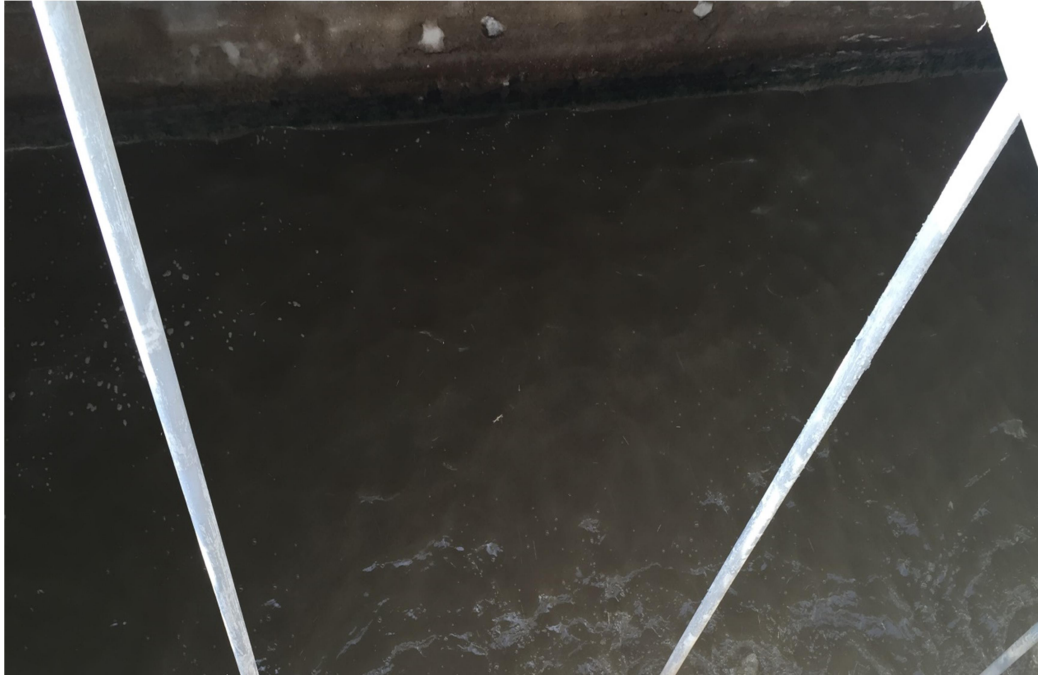
The walls of the ventilation basin after the second day of the start of treatment (observe the loss of sediment from the walls appearing)

The walls of the reception basin after the first day of treatment (note the start of loss of sediment on the walls):

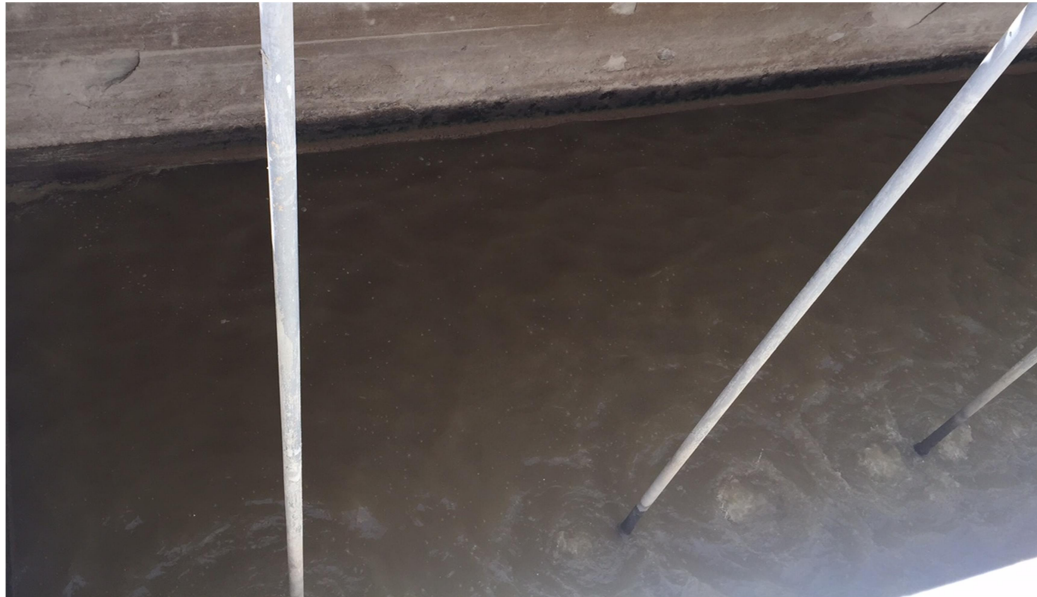
The walls of the reception basin after the tenth day of treatment (observe the change and loss of water color of the majority of the sediment from the walls):

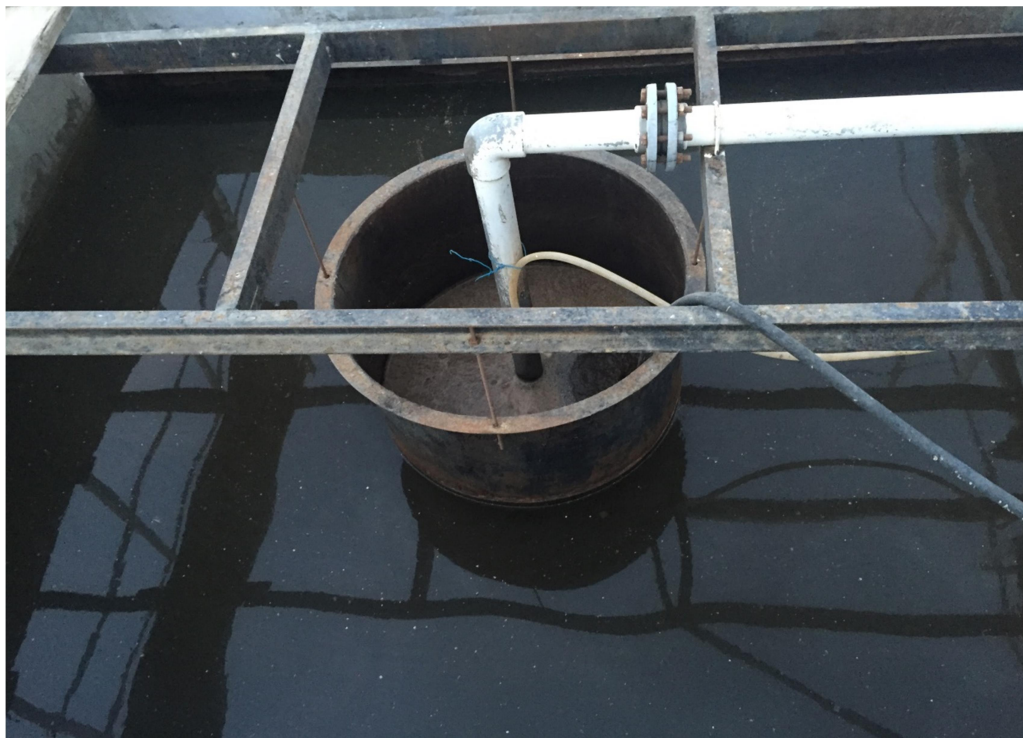
Sedimentation basin on the first day of treatment (disappearance of sludge floating in the tub and the increased turbidity because of the interaction with the residual sludge)

- After five hours of adding the product, the sludge disappeared completely from the top of the sedimentation basin and then the turbidity disappeared completely from sedimentation basin to the extent that the bottom of sedimentation basin appeared whose color was black as a result of sludge sediment since long periods.

- 12 hours after adding the product, the turbidity ratio increased significantly and the color of the water of sedimentation basin turned to the black color, and the same was for the production basin and then the sediment sludge began floating in the bottom of the sedimentation basin gradually on the surface of the tub.

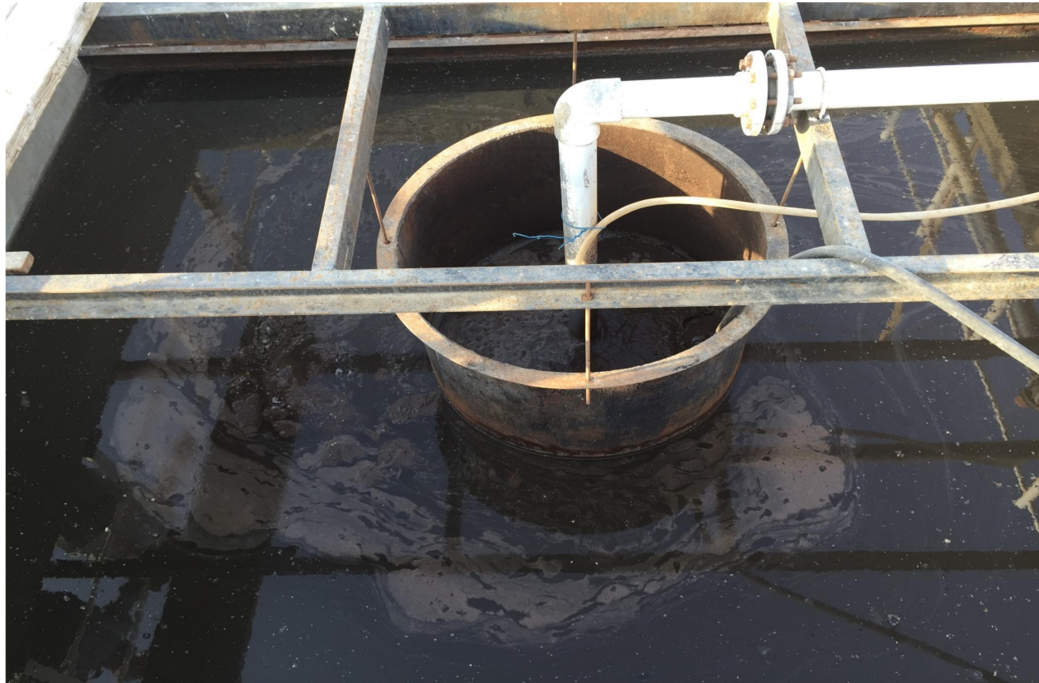
Sedimentation basin on

the second day of treatment (sediment sludge began to appear on the surface as a result of disturbance from the bottom and walls):

- Almost a day after adding the product a layer of sludge floated on the surface of the sedimentation basin as a result of the disturbance of the sediment that was in the pelvic floor and the thickness of sludge increased gradually until the second day to become 2 cm basin covering almost the entire deposition.

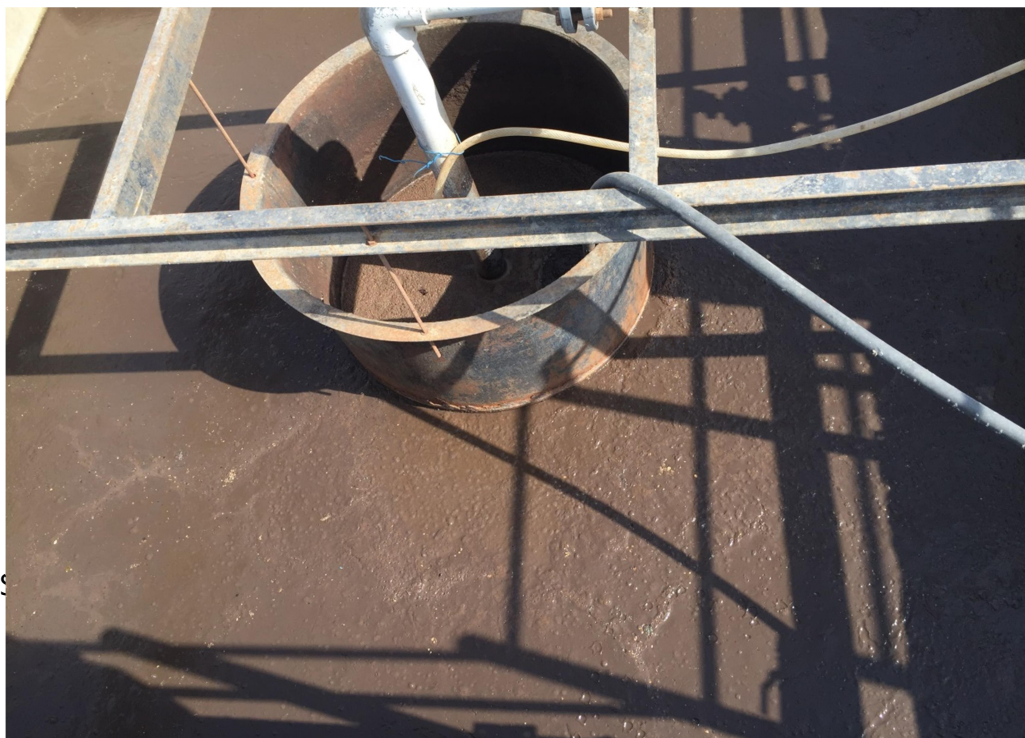
Sedimentation basin on the third day of treatment (floating of sediment sludge to cover the entire surface, the layer should be on the surface with thickness of 2 cm)

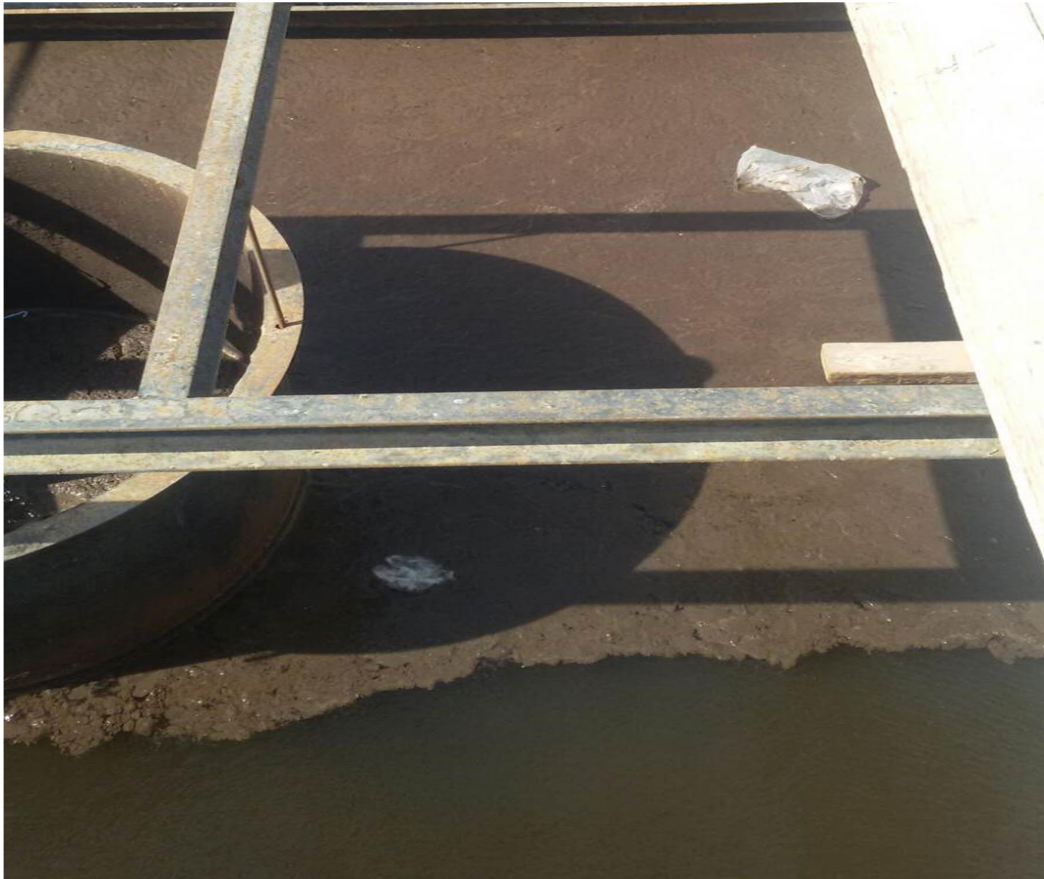
floating on the surface began regularly):

- The beginning from the end of the third day, and as a result of the compound (Septx) interaction with the sludge, the latter began to crumble gradually until it disappeared completely after the fourth day despite an increase in the load on the treatment plant due to higher occupancy rate of the hotel.

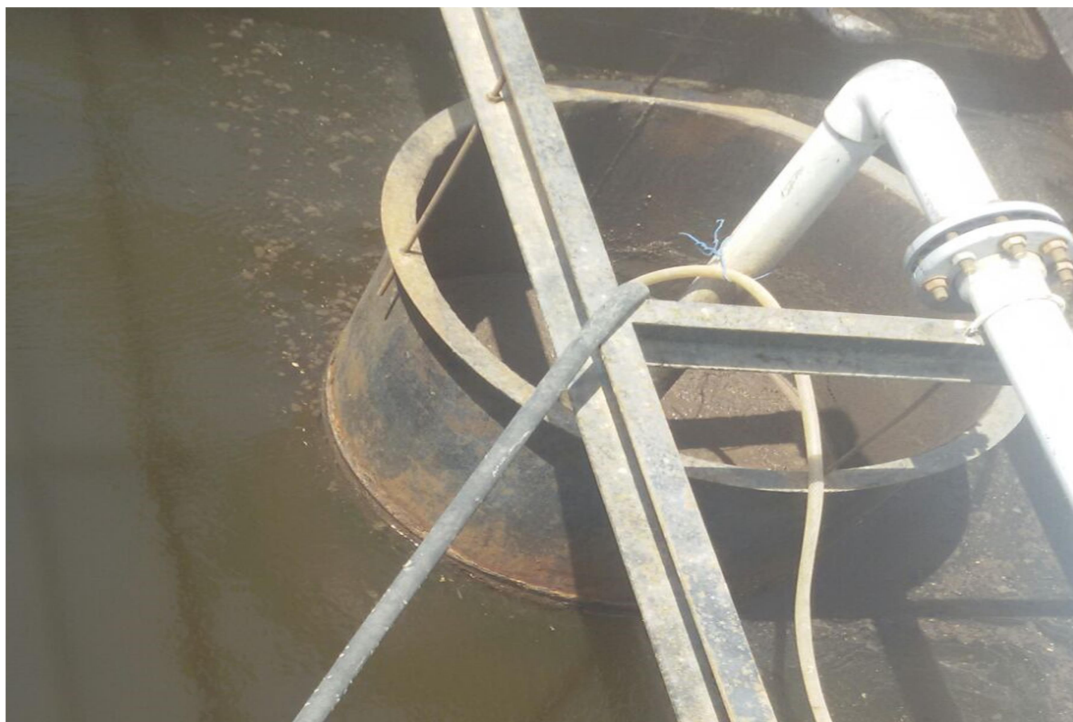
Sedimentation basin on the fifth day (the completion of the disposal of sludge floating layer and the start of the appearance of the water's surface in a pure form)

- **Results and observations interpretation:** The product first interacted with the dissolved sludge that was on a lees form in the basin, which led to the complete disappearance of turbidity at the beginning of treatment, and after the elimination of the dissolved sludge it started to deal with the sediment sludge on the floors and walls and walls of the basins. The treatment was on two phases; the first was a shredding phase which ended by the sludge floating on the surface of the tub and then the phase of the gradual elimination of the sludge until it disappeared completely on the fourth day.

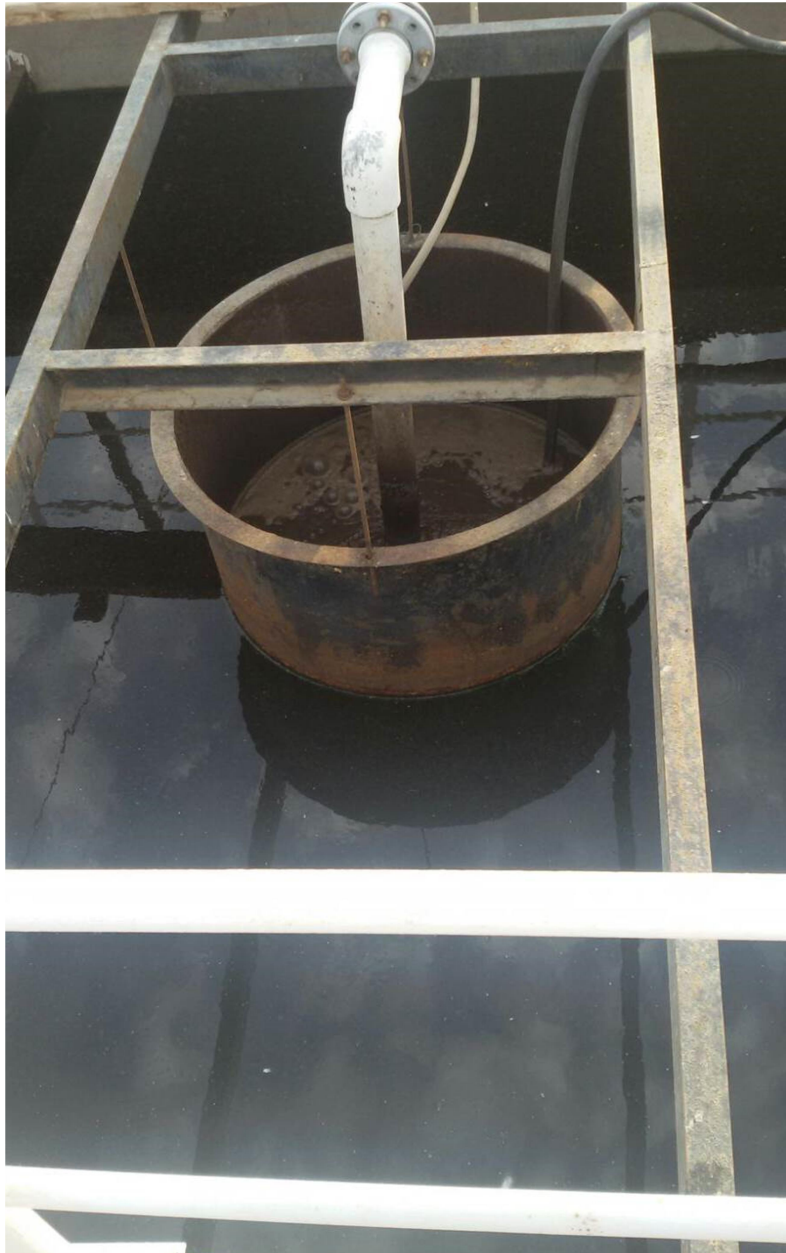
Sedimentation basin on the sixth day (the disappearance of floating sludge layer completely and the appearance of the surface of water in a more pure shape)
